Home Inspection Report

123 Some Street
Somewhere, US 12345

Inspected by:
Clinton Steingraber
CSS Minnesota

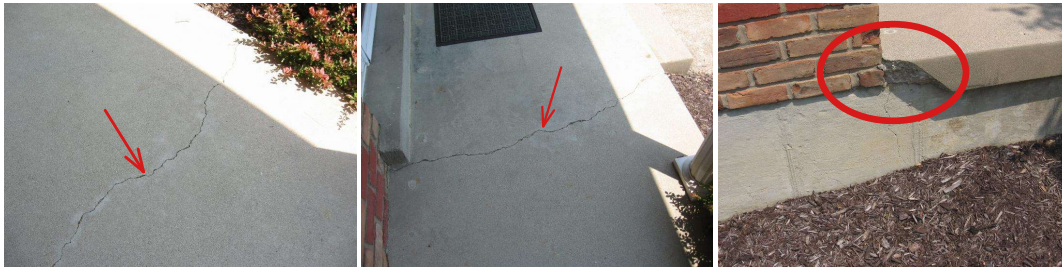
- 1. Driveway: Concrete
- 2. Walks: Concrete
- 3. Porch: Concrete **Settling away from foundation with surface cracks noted**

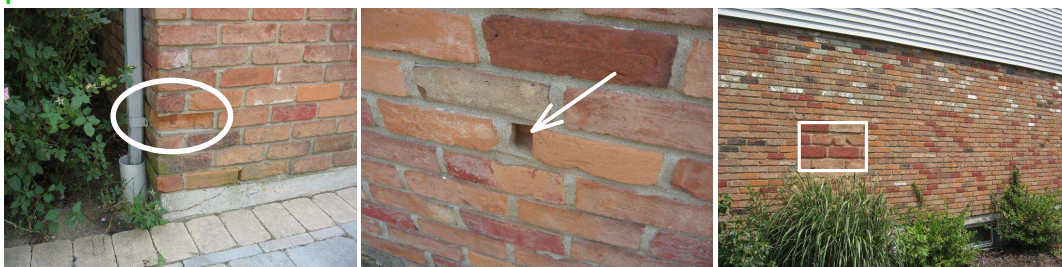
- 1. Type: Brick veneer **Some damaged bricks, Recommend sealing brick with penetration sealer products**

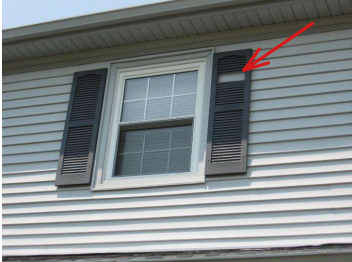
2. Type: Vinyl siding **Damaged front shutter, Chalking noted due to age, One panel needs to be repositioned at rear elevation**

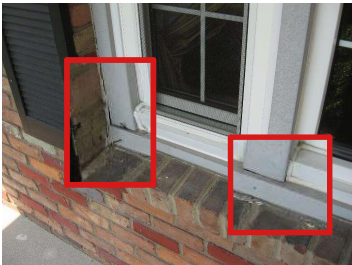
9. Windows: Vinyl insulated **Reseal caulking at window perimeters at brick window openings**

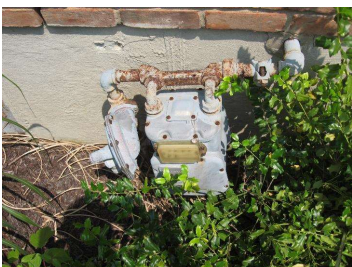
15. Gas Meter: Exterior surface mount at side of home **Rust present, Keep bushes and shrubs away from meter**

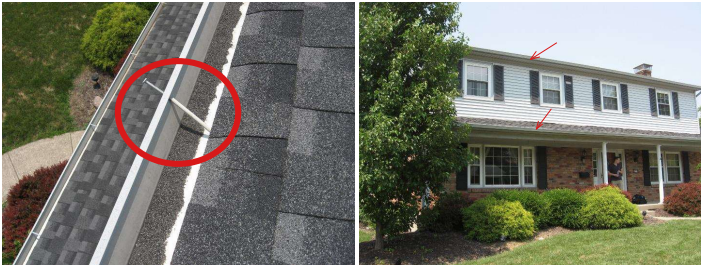
9. Gutters: Aluminum **Loose nails, Sagging gutters at front and rear**

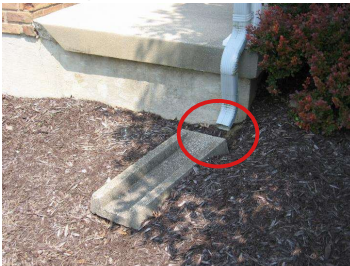
11. Leader/Extension: Splash blocks **Splash block(s) not properly installed**

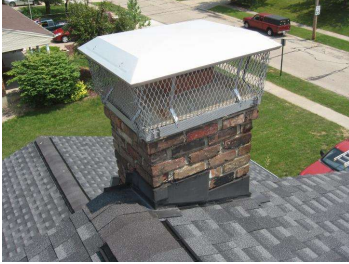
13. Flue/Flue Cap: Clay tile Weather cap obstructed view of flue

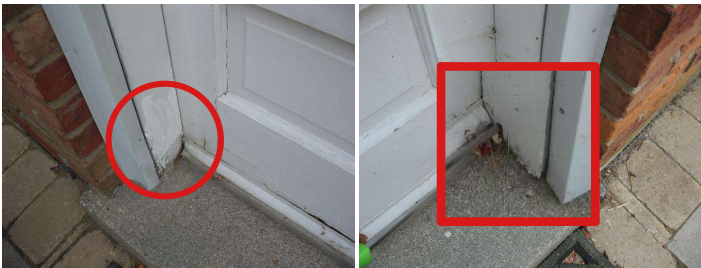
1. Type of Structure: Attached Car Spaces: 2
2. Garage Doors: Insulated aluminum
3. Door Operation: Mechanized
4. Door Opener: Overhead Door
5. Exterior Surface: Brick veneer
6. Roof: Asphalt shingle
7. Roof Structure: 2x6 Rafter
8. Service Doors: Wood **Wood rot at bottom of door and frame**

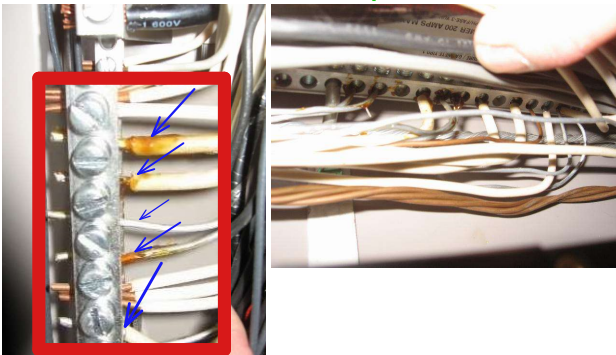
3. 120 VAC Branch Circuits: Copper and aluminum **Evaluation by a licensed electrician is recommended, See aluminum wiring notes below**

5. Aluminum Wiring: Present at several circuits **Aluminum branch wiring has had a history of problems relating to poor connections due to galvanic corrosion, dissimilar metals, brittle conductors and type of aluminum alloy used during the time period of 1965 through 1972. These problems create unsatisfactory conditions at connections and splice locations and therefore create potential fire hazards. Recommend wiring update for aluminum wiring by a licensed electrician, Circuits are recommended to be upgraded with special compression type connectors at splices and branch circuits to reduce the potential risks of aluminum branch wiring.(Cop-Alum Crimp System)**

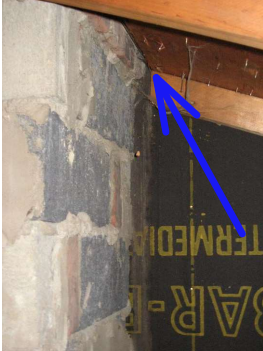
1. Method of Inspection: In the attic
2. Unable to Inspect: 15% Safety and footing
3. Roof Framing: 2x3/4 Truss **Wood blocking components missing at chimney perimeter**

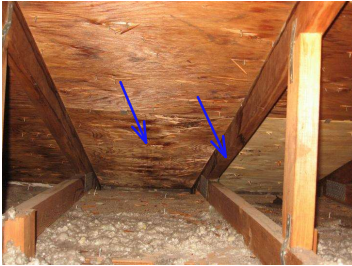
4. Sheathing: Plywood **Water stains and slight damage present, Areas of sheathing have been repaired**

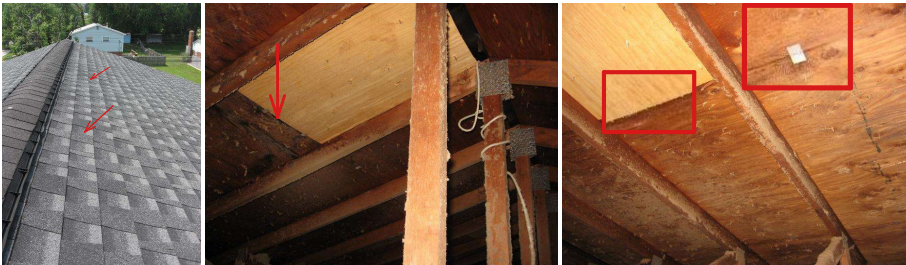
9. Method of Inspection: In the attic
10. Unable to Inspect: 10% Safety and footing
11. Roof Framing: 2x3/4 Truss
12. Sheathing: Plywood **Poor repair at 2 areas near ridge at rear slope - No H clips installed and repair only spanned one truss - Recommend additional support be installed**

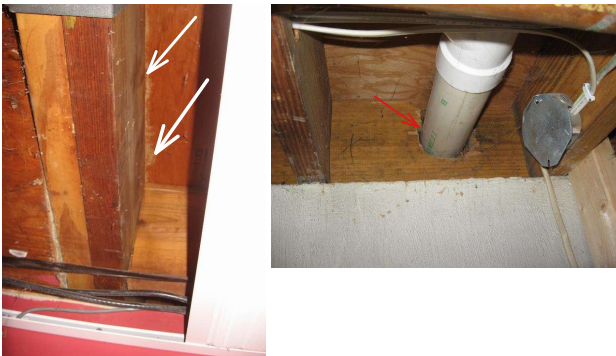
1. Structure Type: Wood frame
2. Foundation: Poured concrete
3. Differential Movement: Slight settlement present Minor settlement at front porch, Cracks will require monitoring
4. Beams: Steel I-Beam
5. Bearing Walls: Wood frame
6. Joists/Trusses: 2x10 **Areas not visible due to ceiling finishes or other obstructions, Framing joist near fireplace chimney shows evidence of previous termite infestation - No repairs required, Seal penetration as required**

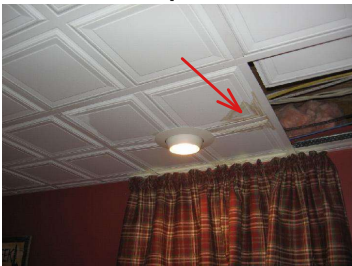
2. Ceiling: Suspended Acoustical System Evidence of past water staining
3. Walls: Drywall
4. Floor: Carpet **Carpet stains noted**

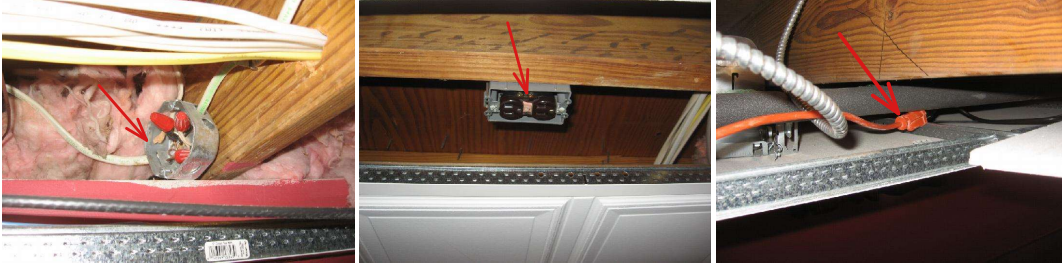
- 5. Floor Drain: Surface drain
- 6. Doors: Hollow wood
- 7. Windows: Vinyl casement
- 8. Electrical: 110 VAC **Loose junction boxes, missing and mis-sized covers, extension cord wiring to projector**

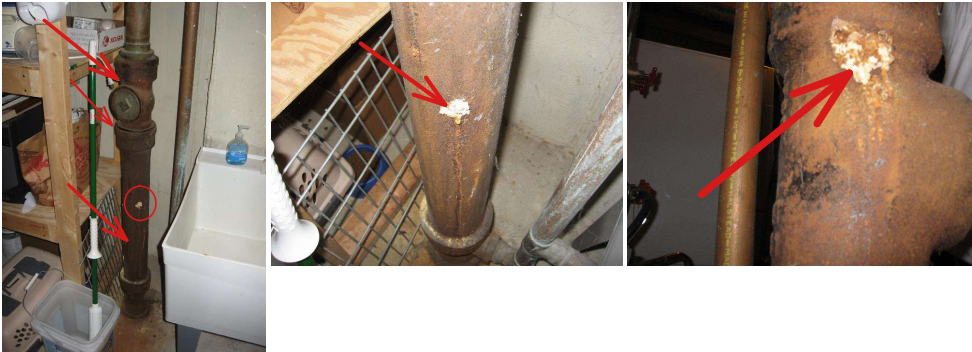
1. Service Line: Copper
2. Main Water Shutoff: Basement
3. Water Lines: Copper
4. Drain Pipes: Cast iron, Copper **Pitting cast iron drain piping stack - replace affected sections where required**

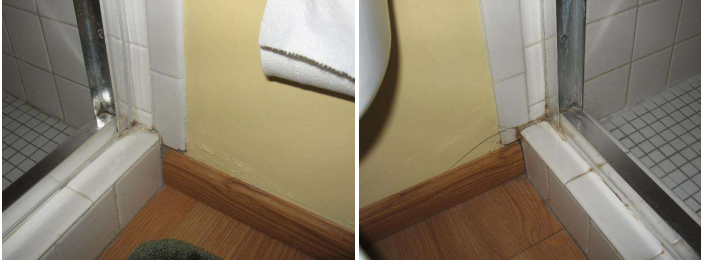
10. Shower/Surround: Ceramic tile **Leaking at corner of door frame**

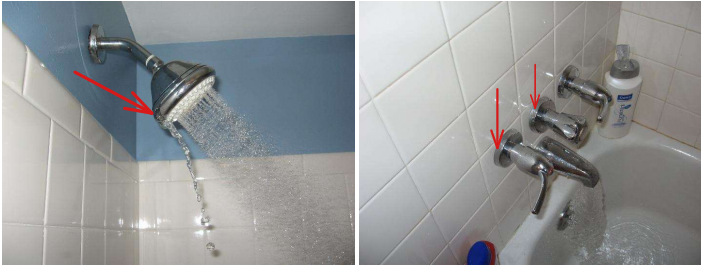
14. Closet: Large **Alignment needed at closet doors**
15. Ceiling: Drywall
16. Walls: Drywall
17. Floor: Laminated flooring **Gapping noted in planks**
18. Doors: Hollow wood
19. Windows: Vinyl Insulated
20. Electrical: GFCI
21. Counter/Cabinet: Wood
22. Sink/Basin: One piece sink/counter top
23. Faucets/Traps: Delta fixtures with a metal trap **Leaking shower head, Loose trim rings**

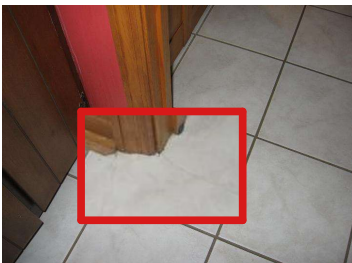
28. Ceiling: Drywall
29. Walls: Drywall
30. Floor: Ceramic tile **Cracked tile noted**

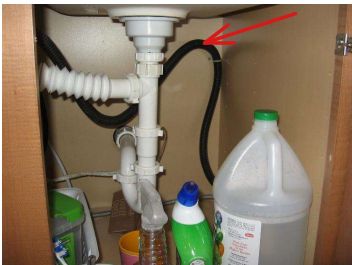
- 1. Cooking Appliances: Frigidaire
- 2. Disposal: General Electric
- 3. Dishwasher: Maytag Properly secure the dishwasher discharge hose so that it creates a "high loop" above the basin drain to minimize food or water backup under dishwasher

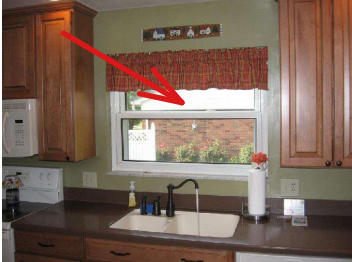
17. Windows: Vinyl Insulated **Insulated glass unit seal failure**

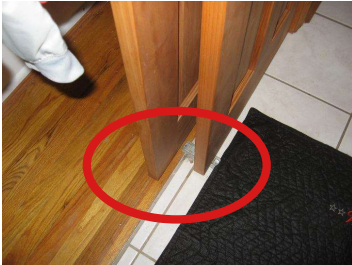
1. Closet: Various **Missing door glides at bypass closet door in Foyer**

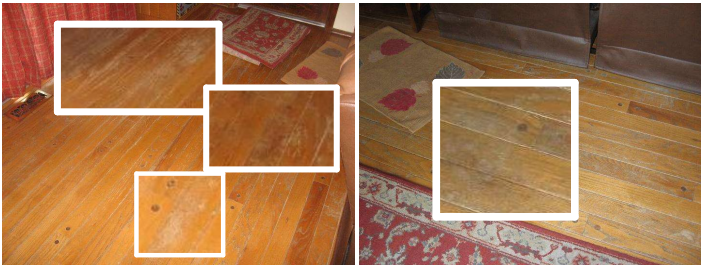
4. Floor: Ceramic tile, Carpet, Hardwood **Worn wood finish in Family room**

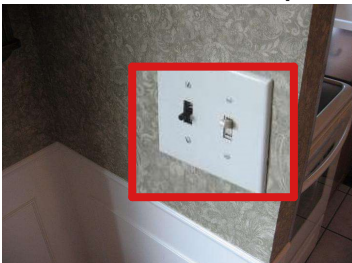
7. Electrical: 110 VAC Replace missing dimmer switch in Dining room

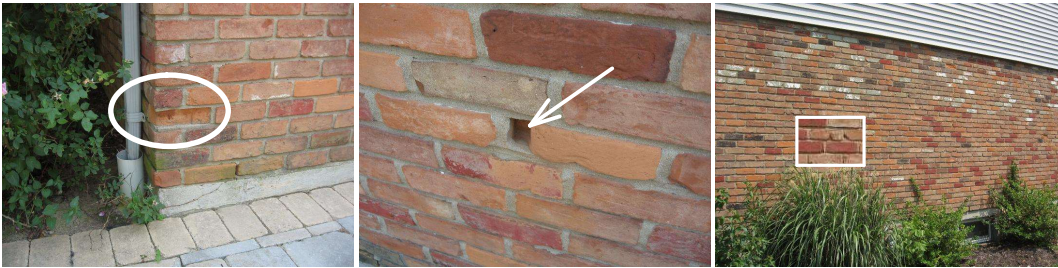
2. 1st Floor Exterior Surface Type: Brick veneer **Some damaged bricks, Recommend sealing brick with penetration sealer products**

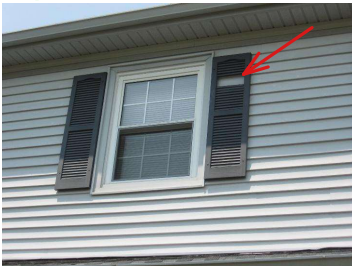
3. 2nd Floor Exterior Surface Type: Vinyl siding **Damaged front shutter, Chalking noted due to age, One panel needs to be repositioned at rear elevation**

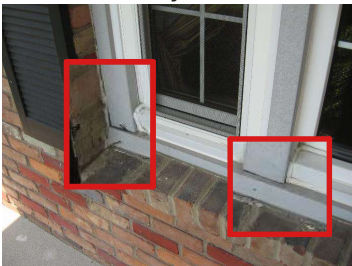
4. Trim: Aluminum **Chalking noted due to age, Loose nails in areas**
5. Soffits: Vinyl **Loose/sagging at front porch**
6. Patio Door: Vinyl sliding **Resecure loose handle hardware, Screen damage noted**
7. Windows: Vinyl insulated **Reseal caulking at window perimeters at brick window openings**

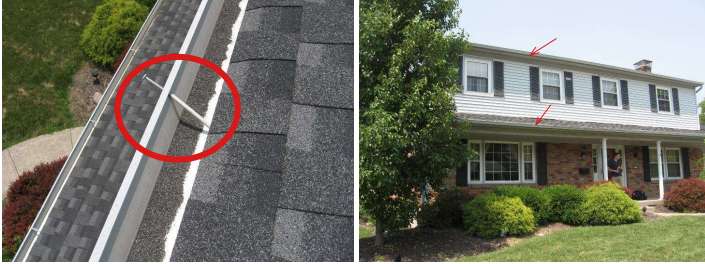
9. Gutters: Aluminum **Loose nails, Sagging gutters at front and rear**

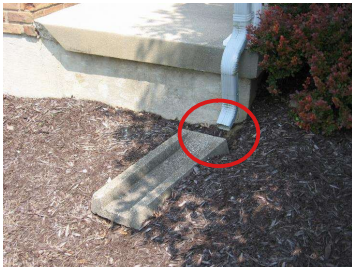
10. Leader/Extension: Splash blocks **Splash block(s) not properly installed**

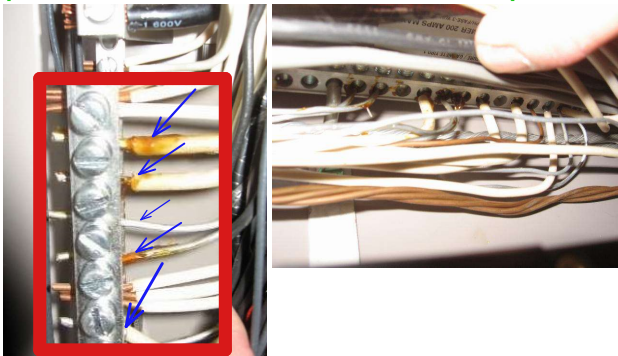
14. 120 VAC Branch Circuits: Copper and aluminum **Evaluation by a licensed electrician is recommended, See aluminum wiring notes below**
15. Aluminum Wiring: Present at several circuits **Aluminum branch wiring has had a history of problems relating to poor connections due to galvanic corrosion, dissimilar metals, brittle conductors and type of aluminum alloy used during the time period of 1965 through 1972. These problems create unsatisfactory conditions at connections and splice locations and therefore create potential fire hazards. Recommend wiring update for aluminum wiring by a licensed electrician, Circuits are recommended to be upgraded with special compression type connectors at splices and branch circuits to reduce the potential risks of aluminum branch wiring.(Cop-Alum Crimp System)**

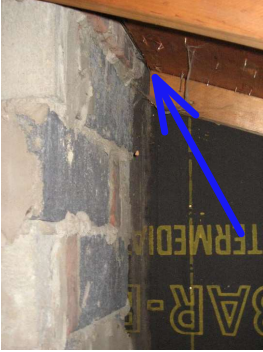
16. Attached Garage Attic Roof Framing: 2x3/4 Truss **Wood blocking components missing at chimney perimeter**

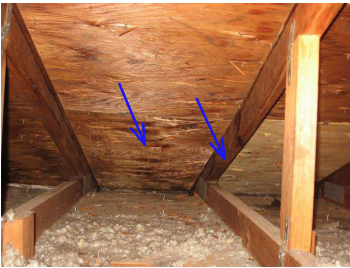
17. Attached Garage Attic Sheathing: Plywood **Water stains and slight damage present, Areas of sheathing have been repaired**

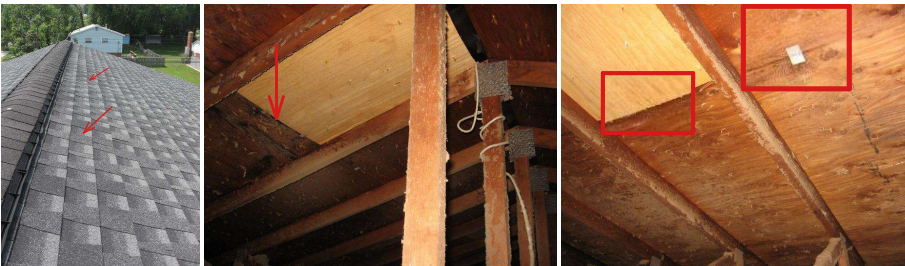
18. Main Attic Sheathing: Plywood **Poor repair at 2 areas near ridge at rear slope - No H clips installed and repair only spanned one truss - Recommend additional support be installed**

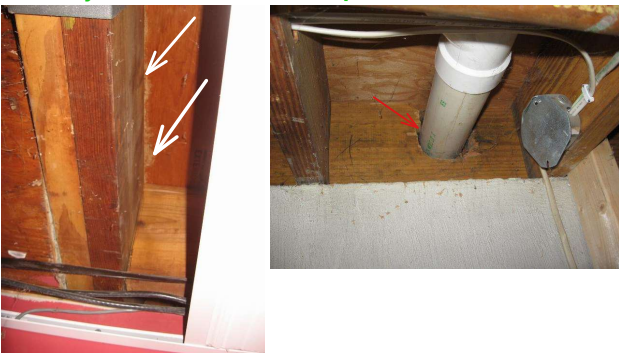
19. Joists/Trusses: 2x10 **Areas not visible due to ceiling finishes or other obstructions, Framing joist near fireplace chimney shows evidence of previous termite infestation - No repairs required, Seal penetration as required**

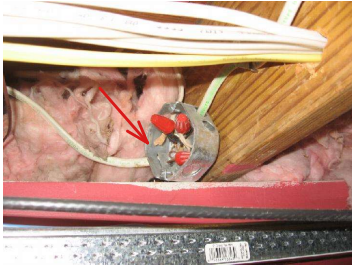
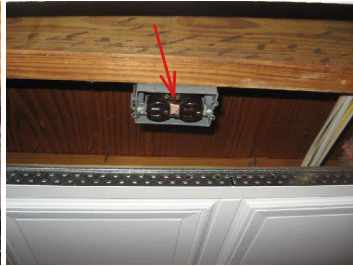
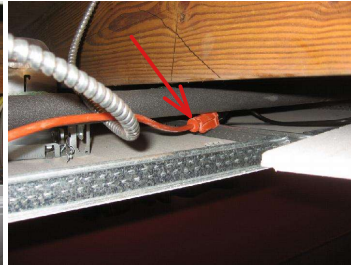
- 20. Main Basement Floor: Carpet **Carpet stains noted**
- 21. Main Basement Electrical: 110 VAC **Loose junction boxes, missing and mis-sized covers, extension cord wiring to projector**

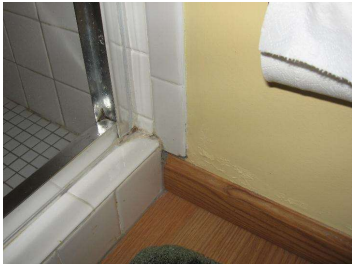
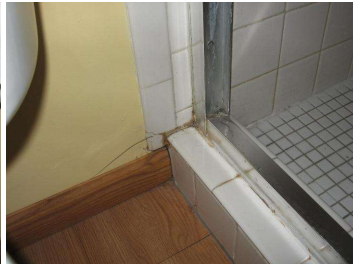
- 22. Master Bathroom Floor: Laminated flooring **Gapping noted in planks**
- 23. Master Bathroom Shower/Surround: Ceramic tile **Leaking at corner of door frame**

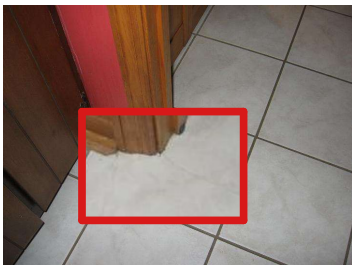
- 24. 2nd Floor Hall Bathroom Closet: Large **Alignment needed at closet doors**
- 25. 2nd Floor Hall Bathroom Floor: Laminated flooring **Gapping noted in planks**
- 26. 1st Floor Hall Half Bathroom Floor: Ceramic tile **Cracked tile noted**

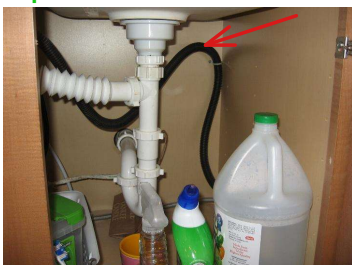
- 27. 1st Floor Kitchen Dishwasher: Maytag **Properly secure the dishwasher discharge hose so that it creates a "high loop" above the basin drain to minimize food or water backup under dishwasher**

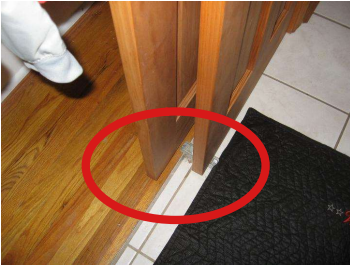
29. 1st Floor Living Space Closet: Various **Missing door glides at bypass closet door in Foyer**

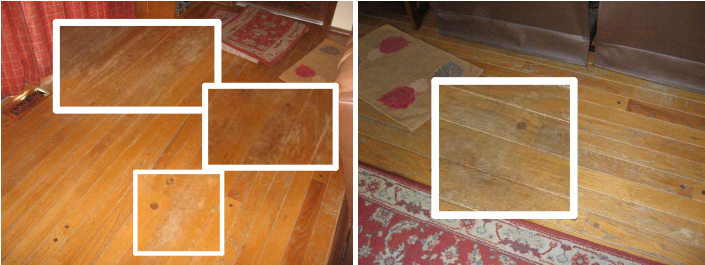
30. 1st Floor Living Space Floor: Ceramic tile, Carpet, Hardwood **Worn wood finish in Family room**

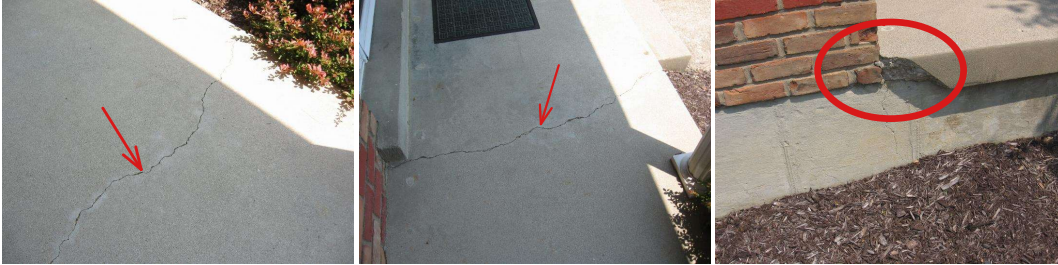
1. Porch: Concrete **Settling away from foundation with surface cracks noted**

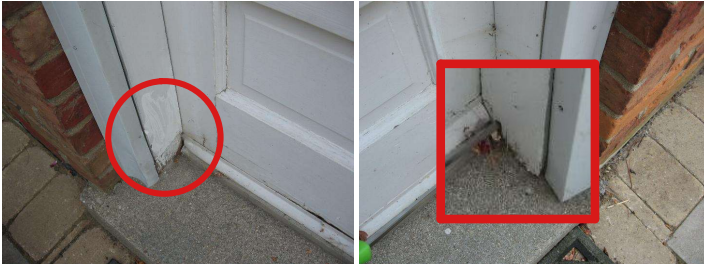
2. Attached Garage Service Doors: Wood **Wood rot at bottom of door and frame**

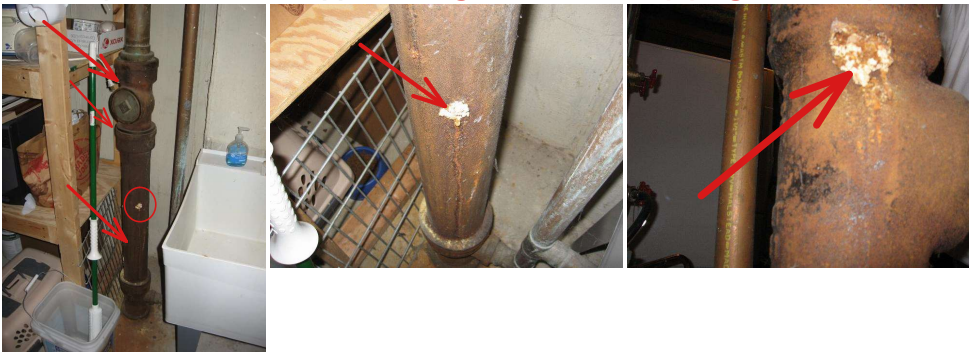
4. Drain Pipes: Cast iron, Copper **Pitting cast iron drain piping stack - replace affected sections where required**

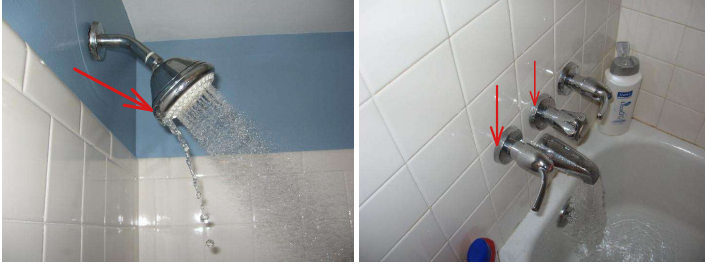
5. 2nd Floor Hall Bathroom Faucets/Traps: Delta fixtures with a metal trap **Leaking shower head, Loose trim rings**

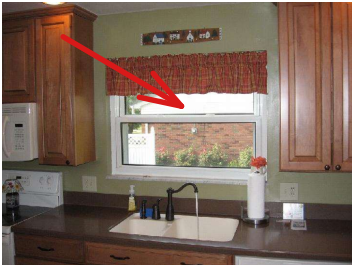
6. 1st Floor Kitchen Windows: Vinyl Insulated **Insulated glass unit seal failure**
